## Case study

### Burford Church, Oxon, OX18 4RY - July 2007 "flash flooding"

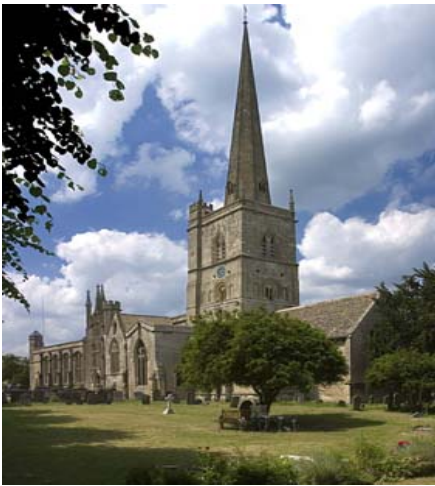
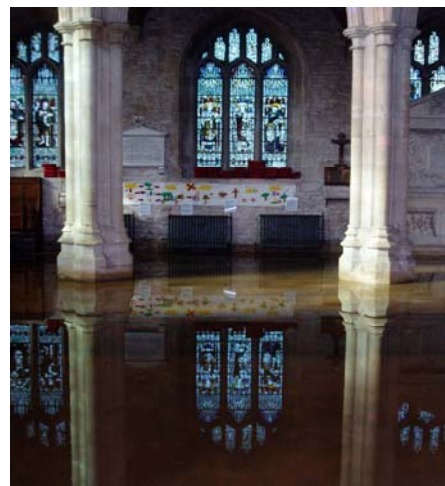
Burford Church was flooded for about 48 hours or so, to an approximate depth of 450mm (18") throughout, following torrential localised rainfall and after the adjacent River Windrush broke its banks.

The stone lower walls, and of course the floors, throughout the Church, were left soaking by the flood, as were many of the contents. A layer of sandy silt was deposited over the entire floor and lower walls of the building, also affecting many floor mounted contents (such as antique chairs and benches, pews, kneelers, altar cloths, tables, bookcases and cupboards) the choir stalls, and so on.

A team of up to 14 people first used vacuum cleaners and soft bristled brushes to gently remove the sandy silt deposits that had been left by the flooding throughout the Church: this minimised the risk of scratching stonework and the beautifully tiled floors. They then used diluted water mixed Ph neutral detergents, developed by our chosen suppliers, to gently wash the floors and walls with soft bristle brushes. The areas were then rinsed with clean water, dried with cloths and then allowed to air dry before being gently sprayed with a specially formulated sanitising "mist" to kill any remaining bacteria. The same approach was applied to pipework and other services, using brushes as small as toothbrushes in inaccessible areas.

Historic buildings such as Burford Church need to be dried gently and slowly and that is exactly what Continuity did: natural ventilation was maximised and a system of large fans was established throughout the Church, with relative humidity measurement readings being taken regularly. The fans were set up so that they drew dry air into the building, at the same time blowing wet air out.
